Notre Dame de Paris 2019 Fire

Notes on the response and early discussions on rehabilitation

Kai Weise and Anie Joshi, ICOMOS Nepal
19 September 2019

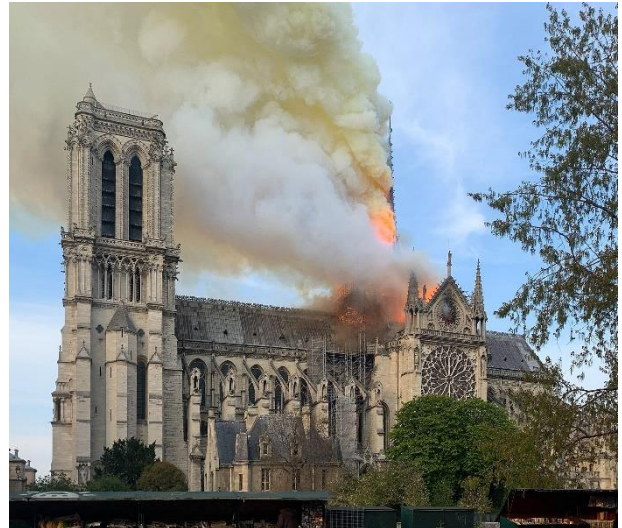
Smoke was seen rising from the roof of the Notre Dame cathedral in Paris and at 6:18 pm the alarm was immediately raised. Though fitted with the most highly sophisticated alarm system with smoke detectors, there was initial confusion about where the fire was located. At 6:45 pm the alarm was raised again while the fire had already spread over the wooden roof structure and by 7:00 pm over six hundred firefighters arrived at the site for the rescue mission. However, within an hour of their arrival at 8:00 pm the spire collapsed and the fire engulfed the entire roof structure.

Figure 1: The blaze around the spire of Notre Dame, Image Wikipedia (Wandrille de Prévile)

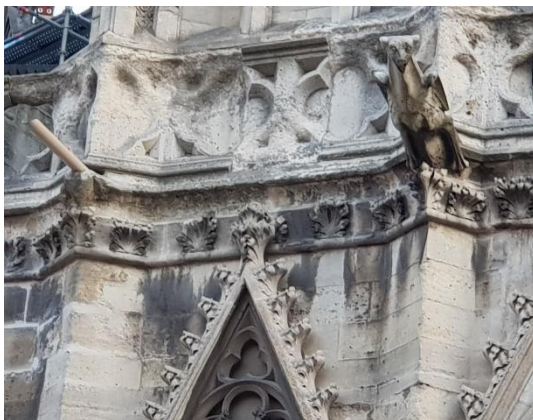
Figure 6: Missing gargoyles and deteriorated stonework - image Kai Weise

However, the state of conservation of the Notre Dame de Paris in the early 2000 was appalling with most of the decorative stone elements including the gargoyle and stone balustrade becoming very fragile. The stone masonry of the flying buttresses was unstable while the spire was tied in place using a metal belt. Therefore, a major restoration project was approved as per the report presented by the conservation architect in 2013. In 2018 work began on restoring the spire and one of the flying buttresses on the southern side. The first task of this project was the restoration of the spire. Therefore, in early 2019 huge steel scaffoldings were installed. The eight allegories (statues) on the spires were removed. A few days later the fire gutted the roof and spire of Notre Dame.

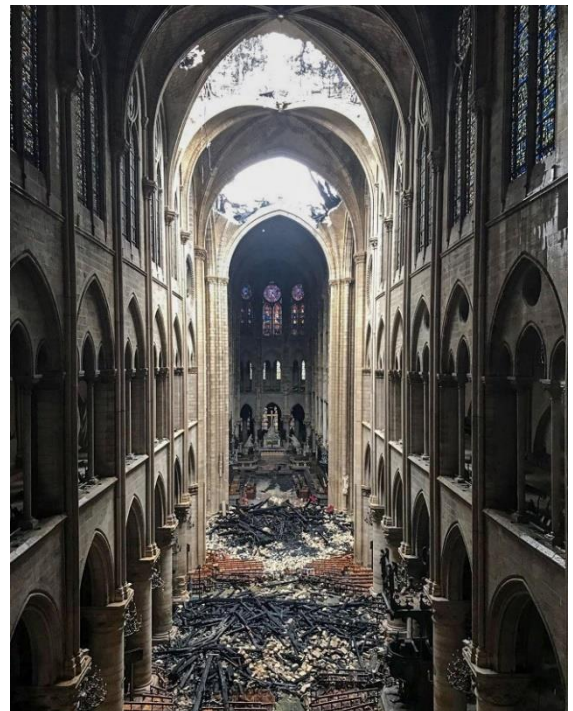
A large fire engulfing the roof and upper sections of Notre-Dame de Paris, with thick smoke rising and scaffolding visible on the left side of the building.

melted and possibly further fuelled the flames. The large sections of wood were later found to be charred only on the surface, which meant that the smaller timber elements were the main fuel for the fire. At 7:37 pm the roof collapsed, beginning with the eastern naïve. The spire which was largely a timber structure caught fire in a spectacular manner and collapsed at around 8:00 pm. The huge steel scaffoldings of the ongoing restoration remained in place but were deformed and welded together by the heat.

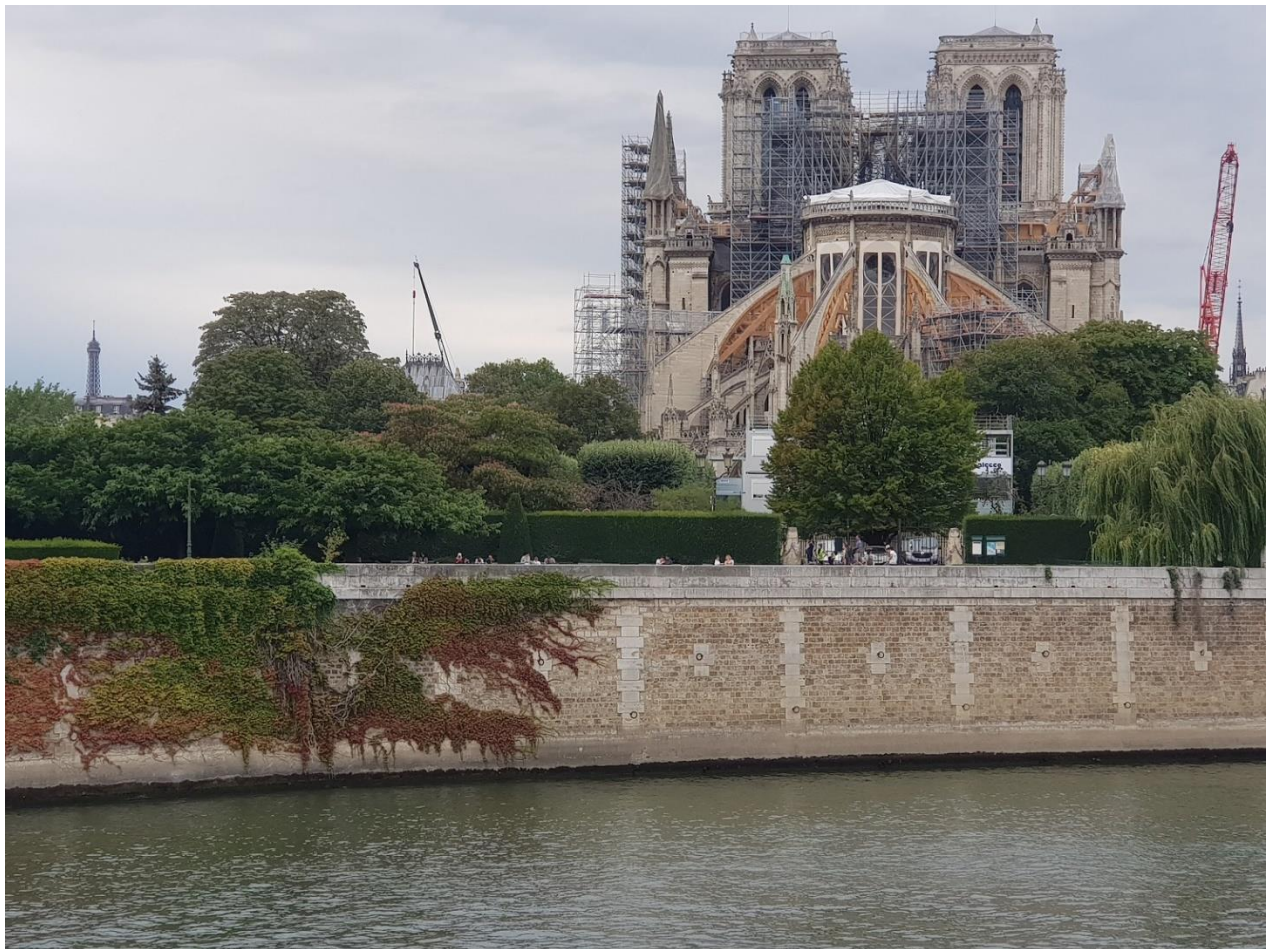
On-site cleaning and emergency stabilisation work have been going on since the week following the fire. Visibly the Notre Dame fire destroyed the timber structure of the roof and central spire. Some timber elements fell through the stone vaults and smouldered on inside the cathedral hall. However, the presence of the stone vault prevented the fire getting into the cathedral. Some stone columns inside the cathedral were found to have been damaged by the heat. However, the detail condition assessment of the monument and the impact of the fire on the masonry structure and the stone vault has not been done yet. Most of the restoration work done on the monument within the last few decades were focused on its architectural features. The damage caused by the fire has necessitated major restoration works and this can be seen as an opportunity to carry out research on the condition of the entire masonry structure from the 12th and 13th century.

Figure 11: The on-going consolidating works on Notre Dame seen from the east across the River Seine with the Eiffel Tower in the distance to the left and the spire of Sainte-Chapelle seen next to the crane to the right – Image Kai Weise

The loss of the roof structure and possible damage of the stone vaults that span the main naïve could impact the overall structural stability. The flying buttresses provide the tall stone columns lateral support, and with the removal of the link at the top, this could put pressure on these columns which might already be weakened due to the fire. As a precautionary measure, timber framing has been inserted inside the flying buttresses to counteract the lateral forces. The gable walls of the roof structure which are freestanding now after the loss of the roof structure have been provided with the timber support structures to avoid further damage. The stained glass of the upper windows has been removed for protection and the openings covered. The vaulted ceiling has been covered to protect it from rain water though this was not possible where the massive scaffolding the still stands, erected around where the spire once stood. The damaged interior columns have been temporarily tied using steel-cables and timber planks packing.

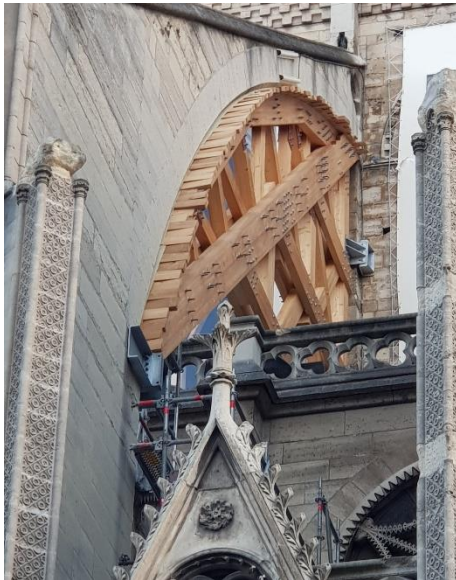
Figure 12: Consolidation of flying buttresses, August 2019 – Image Kai Weise

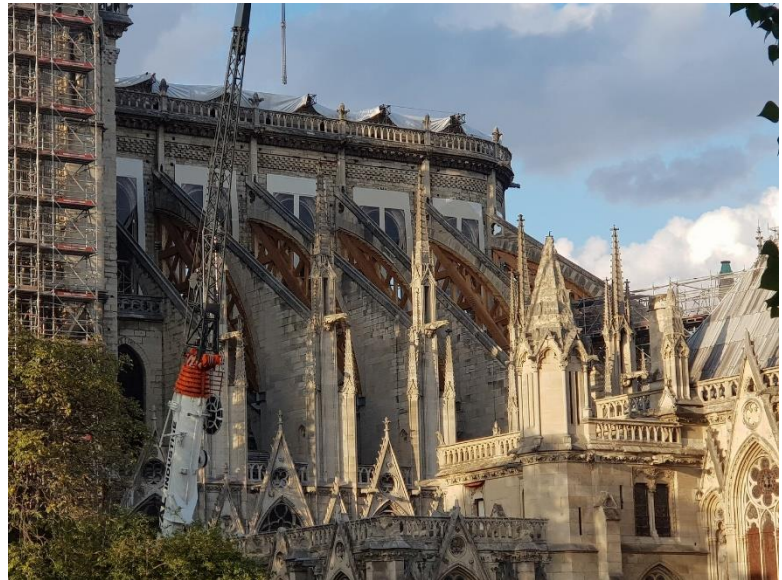
Figure 13: Consolidation of flying buttresses, August 2019 – Image Kai Weise
