Notre Dame de Paris 2019 Fire

Notes on the response and early discussions on rehabilitation

Kai Weise and Anie Joshi, ICOMOS Nepal
19 September 2019

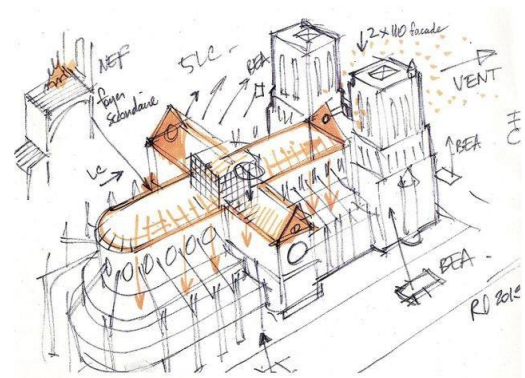
Figure 7: Sketch by firefighters planning strategy on site – Image René Dosne/BSPP

Once the fire was located the response was carried out in a highly professional manner. The firefighters drew sketches planning out the strategy to approach this situation, clearly reflecting their level of training and knowledge of the historic structure. Water was pumped from the Seine to spray on the inferno while important artefacts were removed from the monument including the most precious relic, the Holy Crown of Thorns. Emergency evacuation was carried out successfully as per preparatory planning.

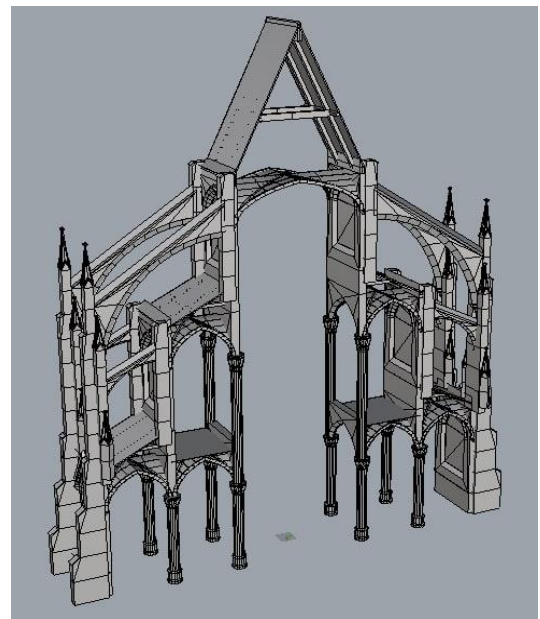
Figure 14: 3D section showing construction elements including stone vaults and timber roofing structure - <http://www.turbosquid.com>

The burning roof structure and the melted lead fell on the stone vaults. It will be a challenge to clean the stone gargoyles from the melted lead drained through them and solidified. The incredible heat that was generated would have affected the stone as well as the lime mortar. Furthermore, the water that was used to douse the fire would have washed away some of the mortar. This is possibly one of the most critical points requiring assessment to know if the stone vaulted ceiling could be restored or will require complete dismantling. It would of course be possible to inject mortar in between the stone elements if the stone itself hasn't been affected too much. For the detail assessment, two working platforms will be installed above and below the vaulted ceiling.

The next important step once the structure is provided with support and protection will be to carry out a detailed diagnosis. The stone vaults that are only about 24-centimetre-thick would be very vulnerable after the fire and need to be observed. The main walls are considered to be stable however also need to remain under observation. There are however very few engineers in France (or anywhere in the World) who understand traditional structures well. In the Middle Ages when the cathedrals were built, the roof was constructed first to provide weight on the loadbearing system before the stone vaults were constructed.

Considering the safety of the people working on site, temporary stabilisation and site preparation with installation of working platforms will be put in place inside the cathedral before the assessment commence. All the material that has been collected from the destroyed sections of the monument has been stored on site in front of the cathedral.
